BB&T - Prop Insp with Sketch

File #: OMS-167922

Property Owner: HPS Pharmacy Street: 312 Diamond St City: Sistersville State: WV Zip: 26175 Mobile Year: Mobile Serial #: HUD #:

Inspection Date: 8/5/2014

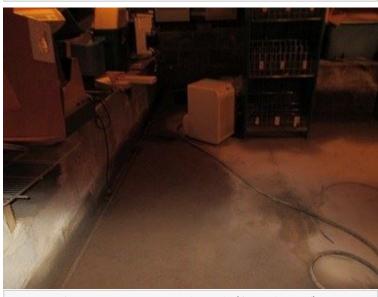
Hazards/Needed Repairs: Potential fire hazards in storage areas. Basement steps- no railing. The underside of the front awning is peeling paint. The basement shows evidence of recent water incursion/seepage from rain.

basement: water seepage from rain (damp afterward)
