# PCR and OCN Lock Change

File #: 193981

Job #: WILL-080905-262854

Property Owner: 1756 SAPPHIRE RANCH TRL  
 Address Street: 1756 SAPPHIRE RANCH TRL  
 Address City: CORVALLIS  
 State: MT Zip: 59828  
 Mobile Year:  
 Mobile Serial #: HUD #:

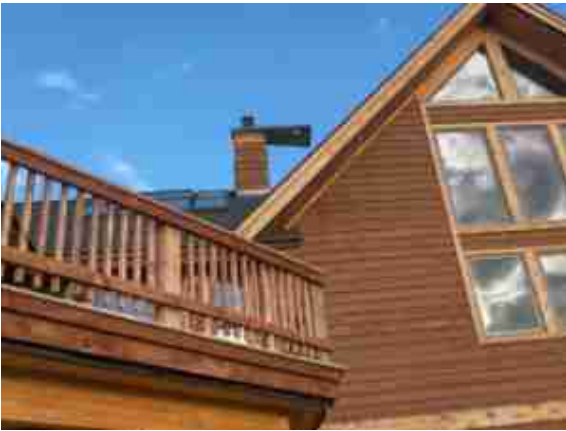
i262854P

Two chimney covers are off. One is totally missing and the other is hanging loose. There are a number of electrical covers and fixtures that are missing. The yard is over grown with weeds and much of it is on a hill side and will be easily mowed. the rep does not have a cell phone so the information about it came from the next door neighbor. He did not indicate any problems with the coverage so the rep rated as good.

(1756 Sapphire Ranch Trail chimney cover blown loose.)

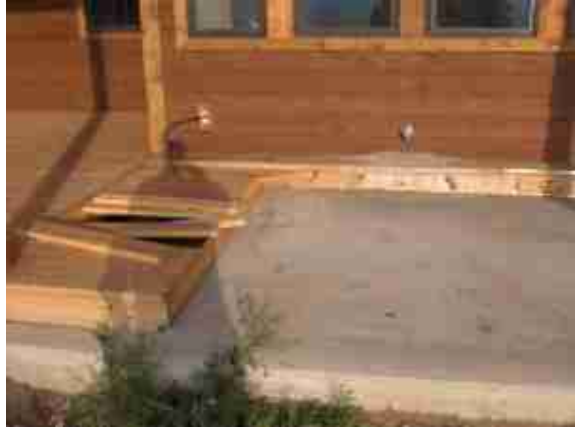
i262854K

(1756 Sapphire Ranch Trail missing portion of deck)

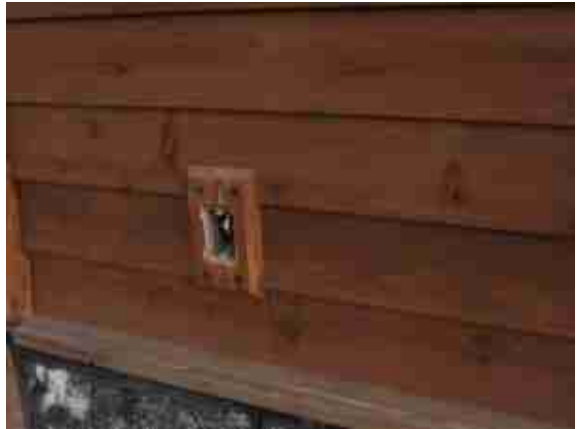
i262854O

(1756 Sapphire Ranch Trail missing fixture/outlet.)

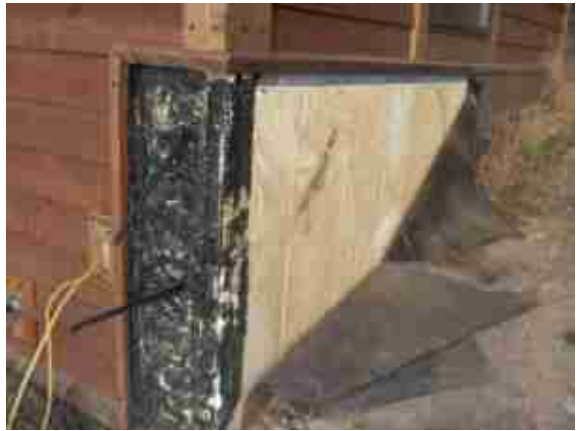
i262854Q

(1756 Sapphire Ranch Trail tar paper pealed loose.)

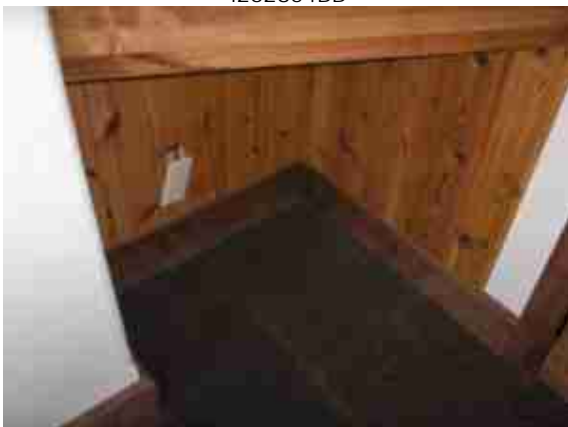
(1756 Sapphire Ranch Trail bedroom #2 loose cover.)  
i262854BD

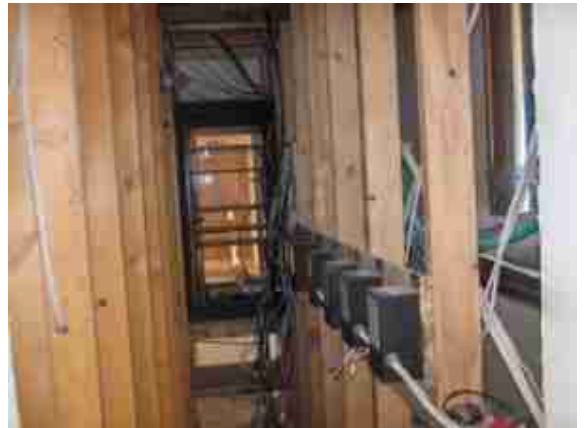
Explain condition of Basement: While this daylight basement is finished, some of the cabinets and fixtures are not finished or missing parts. There are 3 missing sinks and two missing counter tops.

(1756 Sapphire Ranch Trail unfinished section in theater room.)  
i262854BS

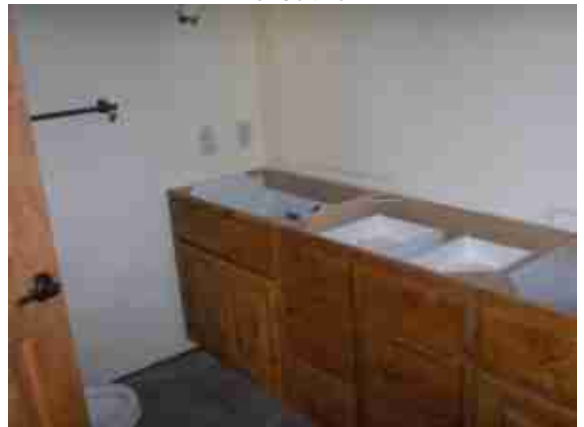
(1756 Sapphire Ranch Trail theater room bathroom with missing counter top and sinks.)  
i262854BU

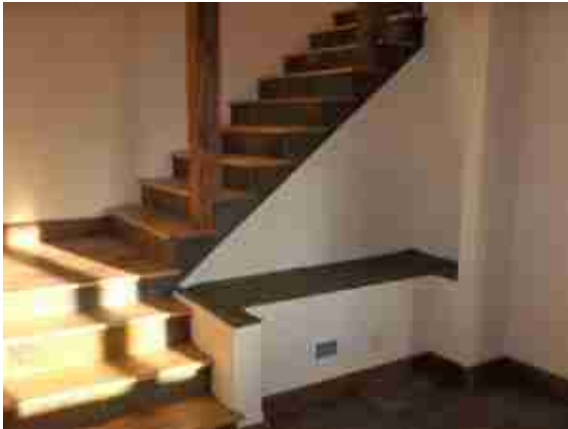
(1756 Sapphire Ranch Trail no rail on stairs.)  
i262854BX

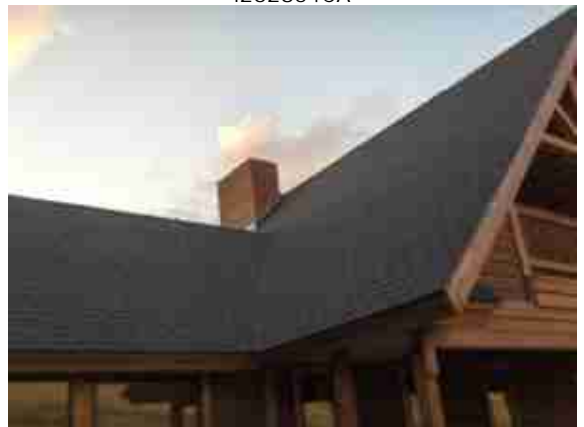
(1756 Sapphire Ranch Trail missing chimney cover.)  
i262854CC

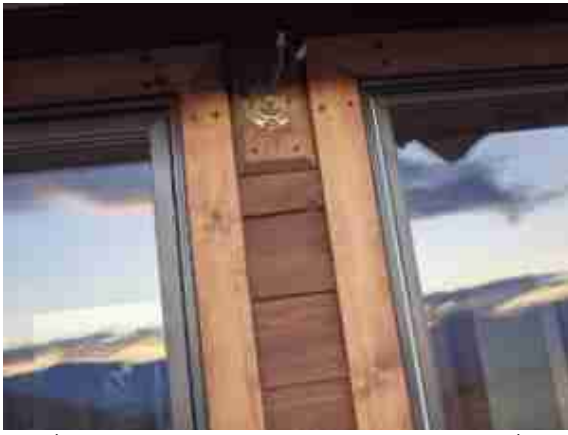
(1756 Sapphire Ranch Trail missing fixture.)  
i262854CD

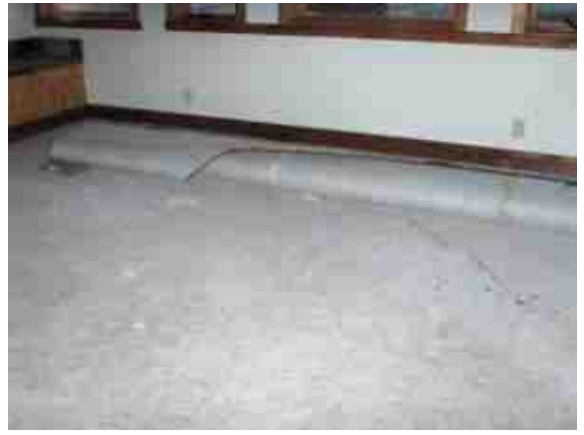
The home is in good overall good condition. However, the master bedroom's carpet is rolled up and the subfloor is very faded. In talking to the neighbor, they said that a pipe had broken and flooded the bedroom. The garage ceiling below it has been removed as well. The outlet covers in the garage are missing as well. The master bedroom's bathroom has a Jacuzzi and walk-in closet. It also has access to a private loft and deck. The other bedrooms seem to be in good condition but the one in the front of the home has a bad smell in it. Also, its bathroom has a hole in its ceiling that will need patching. The kitchen, living room, sun room, dining room, the two lofts, master bath, the main floor bathroom, the 3rd bedroom bathroom, work room, and theater room all were in good condition. The game room had missing counter tops and missing sink. The theater bathroom is missing its counter top and sink. The bathroom in the game room is missing its sink. There are a total of 4 full baths and 2 half baths. The covers for two of the chimneys have blown off or are loose. There is one light fixture that is missing on the outside. The daylight basement has a section missing. The foundation has loose tar paper in one area. The yard is over grown with weeds as is the driveway up to the home. The home has hardwood floors in most of it and has 3 fireplaces. The appliances in kitchen are of very high quality. There is a lot slate through out the home on counter tops and in the bathrooms. There is a great view of the Bitterroot Mountains both from inside the home and from the decks. There are decks on all three levels with some that are only accessed from their respective rooms.

Good	Avg	Poor	Missing	N/A	Comments:	Repair Total
Flooring Material	e	e	e	b	e	Carpet rolled up on floor, it may have water da	\$ 800
Sub-Floor	e	e	b	e	e	Very faded from water damage.	\$ 300
Walls	b	e	e	e	e		\$ 0
Wall Paint	b	e	e	e	e		\$ 0
Ceiling	b	e	e	e	e		\$ 0
Ceiling Paint	b	e	e	e	e		\$ 0
Interior Trim	b	e	e	e	e		\$ 0
Door(s)	b	e	e	e	e		\$ 0

(1756 Sapphire Ranch Trail water damage in master bedroom.)  
i262854CE

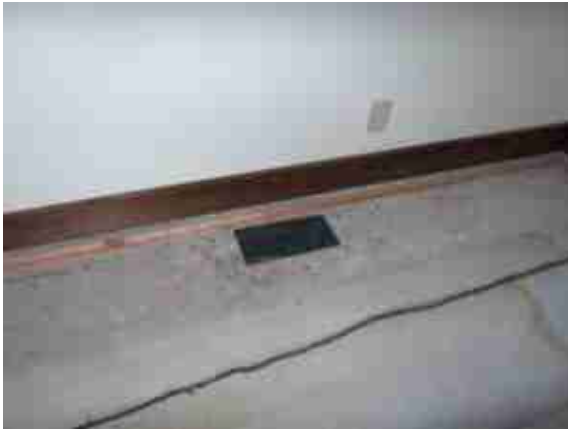
(1756 Sapphire Ranch Trail vent cover open and more evidence of water damage.)  
i262854CF

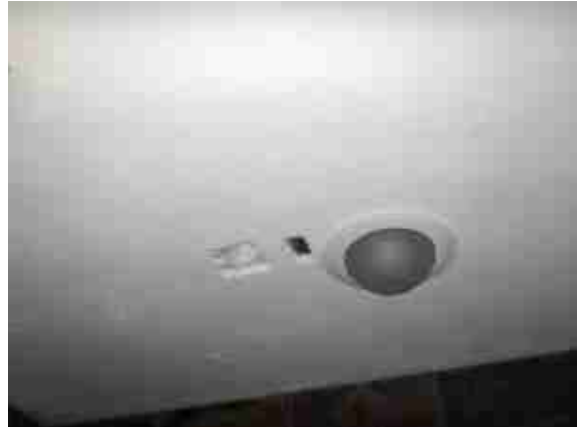
(1756 Sapphire Ranch Trail hole in bedroom 2 bathroom ceiling.)  
i262854CG

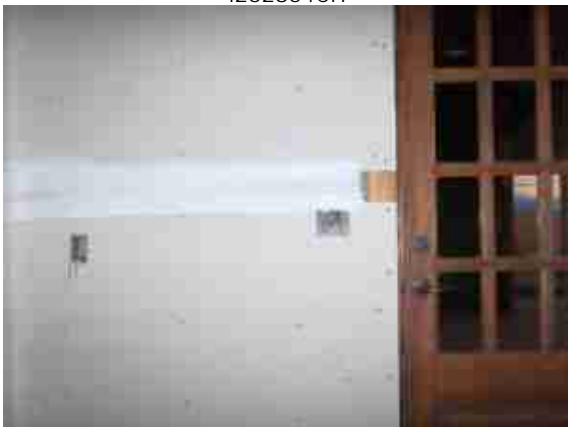
Good	Avg	Poor	Missing	N/A	Comments:	Repair Total
Flooring Material	Ⓒ	€	€	€	€		\$ 0
Walls	€	Ⓒ	€	€	€	Missing outlet covers and other fixtures.	\$ 0
Ceiling	€	€	€	Ⓒ	€	The ceiling has been removed because of the 1	\$ 450
Windows	Ⓒ	€	€	€	€		\$ 0
Overhead Door (s)	Ⓒ	€	€	€	€		\$ 0
Pedestrian Door	Ⓒ	€	€	€	€		\$ 0

(1756 Sapphire Ranch Trail missing covers/fixtures in garage.)

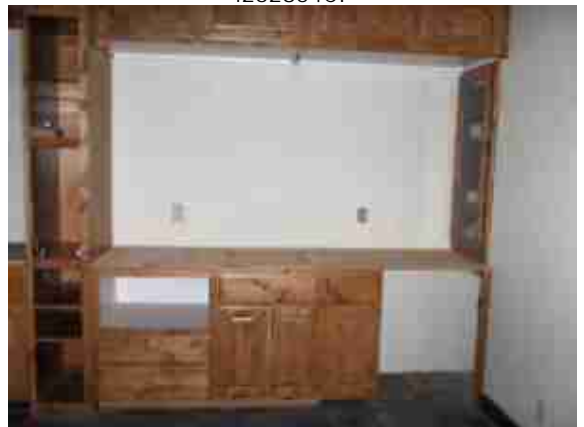
i262854CJ

(1756 Sapphire Ranch Trail missing counter top and outlet cover.)

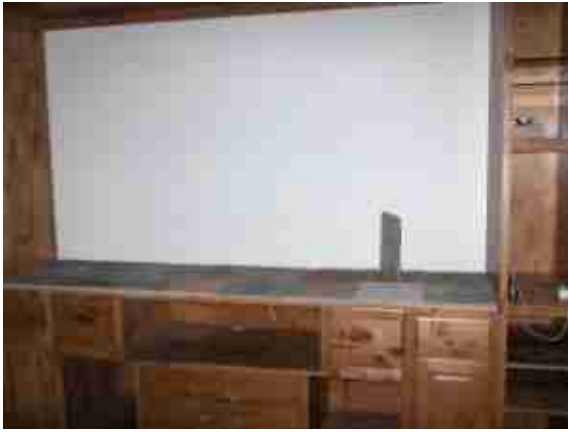
i262854CK

*(1756 Sapphire Ranch Trail loose slate.)*

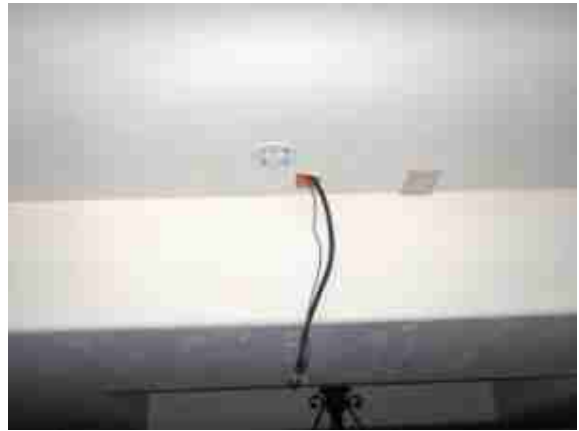
i262854CL

*(1756 Sapphire Ranch Trail loose wire hanging from ceiling in game room.)*
