# PCR and OCN Lock Change

File #: 193981

Job #: WILL-080905-262854

Property Owner: 1756 SAPPHIRE RANCH TRL  
 Address Street: 1756 SAPPHIRE RANCH TRL  
 Address City: CORVALLIS  
 State: MT Zip: 59828  
 Mobile Year:  
 Mobile Serial #: HUD #:

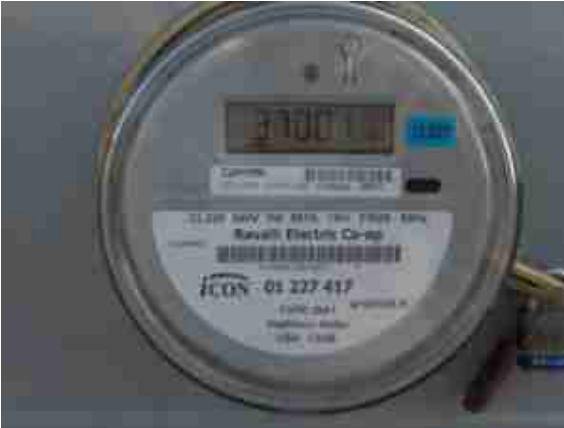
i262854D

**Electric Meter Missing/Removed:**  Yes

(1756 Sapphire Ranch Trail Electrical Meter)

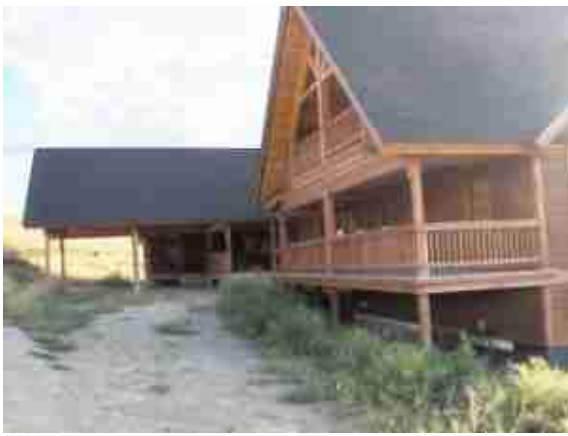
i262854Q

(1756 Sapphire Ranch Trail view of front from north side.)  
i262854R

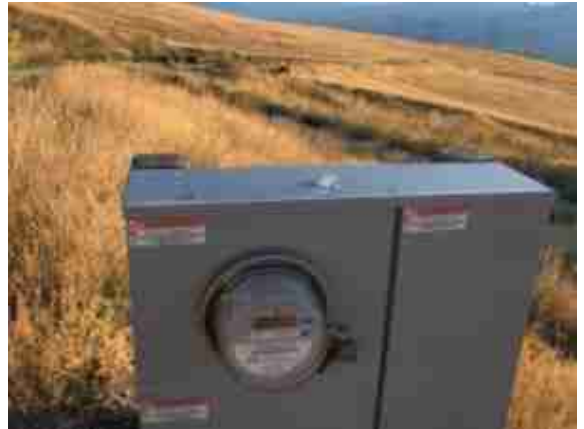
(1756 Sapphire Ranch Trail key taped on electrical meter box.)  
i262854BY

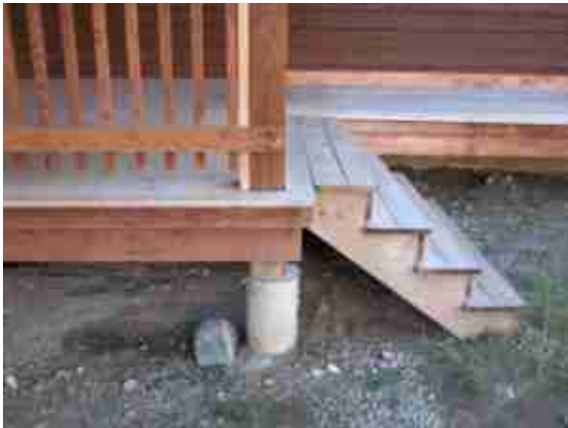
(1756 Sapphire Ranch Trail key is hidden under large rock under the deck behind the steps.)  
i262854BZ

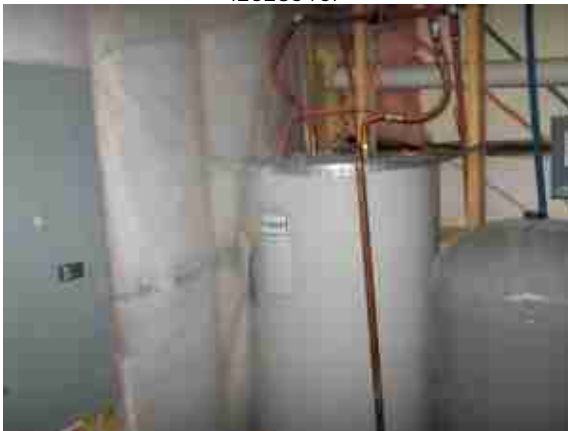
(1756 Sapphire Ranch Trail hot water tank.)  
i262854CH

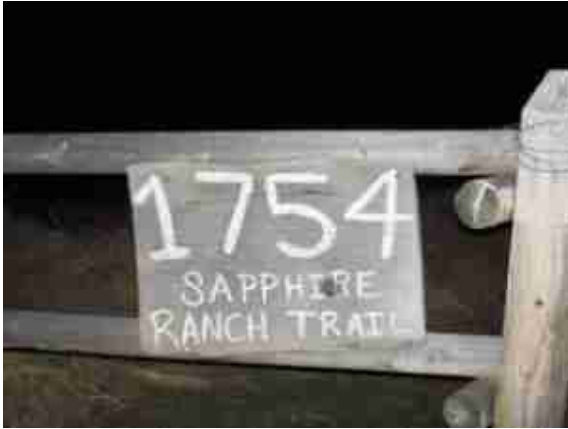
*(1756 Sapphire Ranch Trail address of next door neighbor because this address was not marked.)*
