# PCR and OCN Lock Change

File #: 193981

Job #: WILL-080905-262854

Property Owner: 1756 SAPPHIRE RANCH TRL  
 Address Street: 1756 SAPPHIRE RANCH TRL  
 Address City: CORVALLIS  
 State: MT Zip: 59828  
 Mobile Year:  
 Mobile Serial #: HUD #:

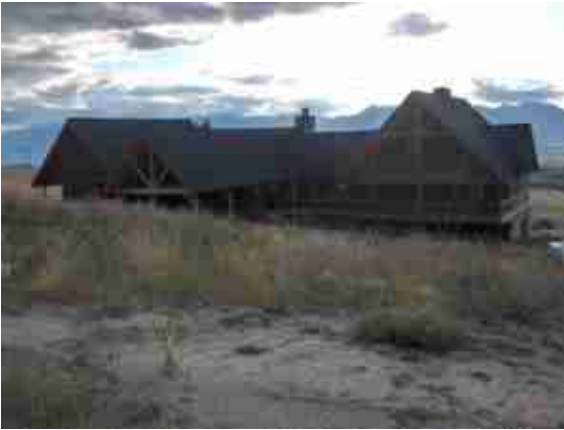
i262854B

(1756 Sapphire Ranch Trail Front Side)

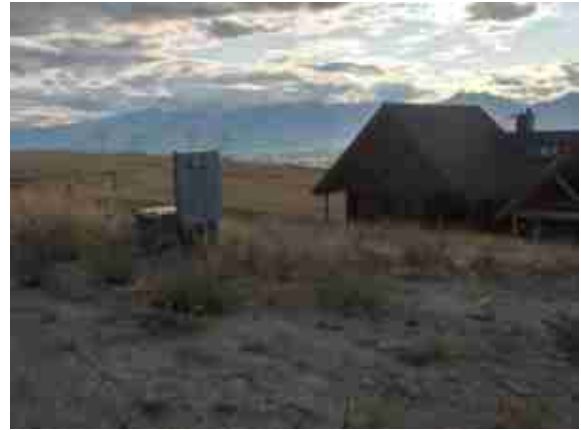
i262854C

(1756 Sapphire Ranch Trail View to Southwest.)

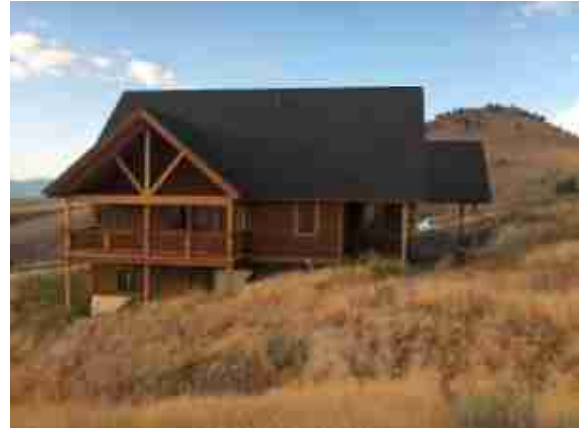
i262854E

(1756 Sapphire Ranch Trail South side)

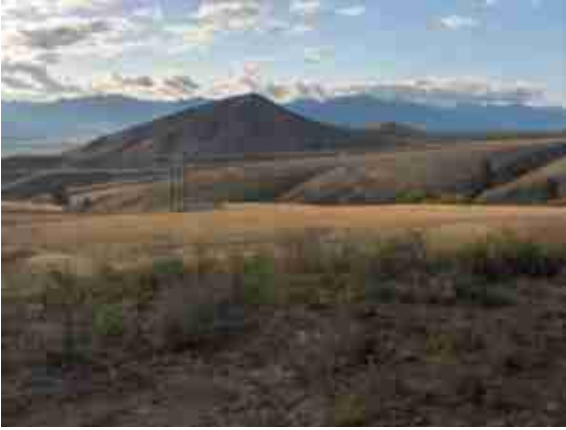
i262854H

(1756 Sapphire Ranch Trail from back looking northwest)

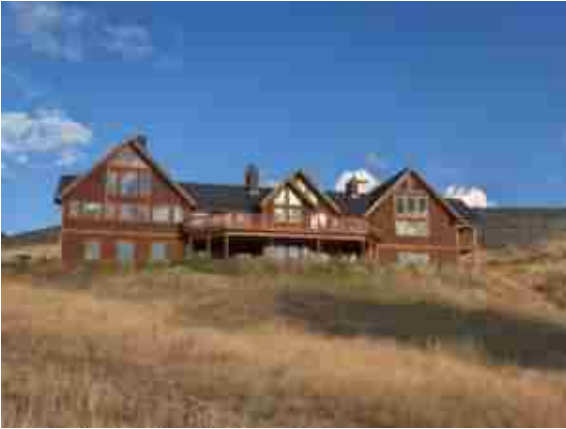
i262854J

(1756 Sapphire Ranch Trail beauty shot 2 and west side of home.)

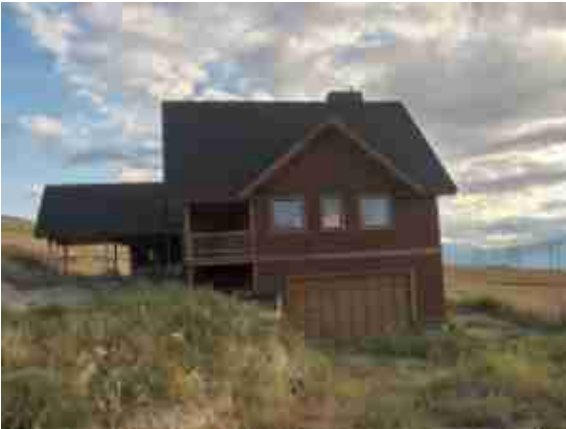
i262854L

(1756 Sapphire Ranch Trail north side of home.)

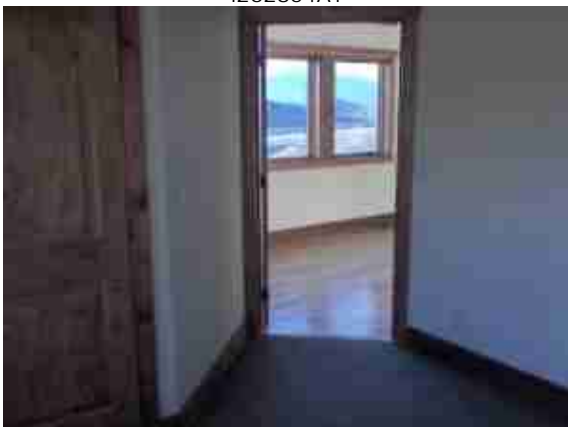
(1756 Sapphire Ranch Trail bedroom number 3 ( 3).)  
i262854AV

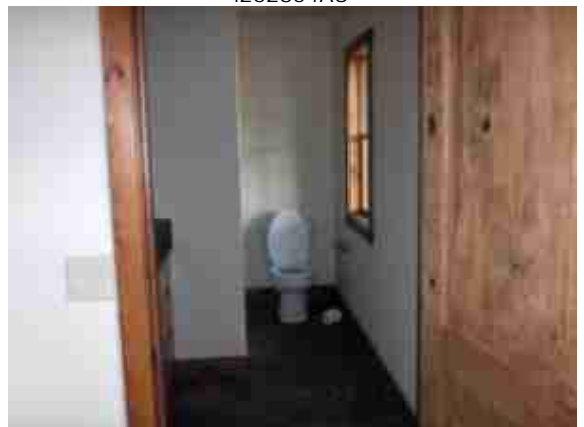
(1756 Sapphire Ranch Trail bedroom number 3 bathroom (1))  
i262854AW

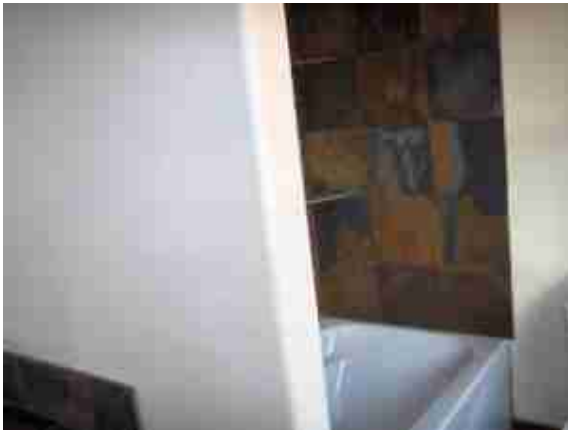
(1756 Sapphire Ranch Trail bedroom #3 bathroom (2).)  
i262854AX

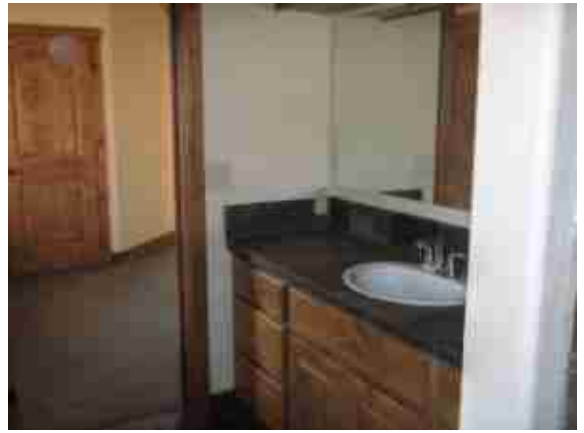
(1756 Sapphire Ranch Trail bedroom #3 bathroom (3))  
i262854AY

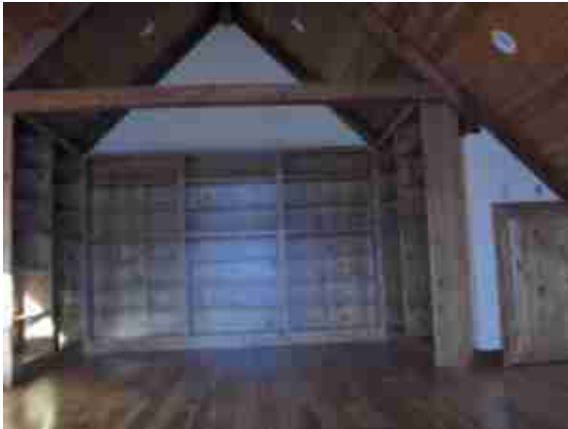
(1756 Sapphire Ranch Trail living room loft 1.)  
i262854AZ

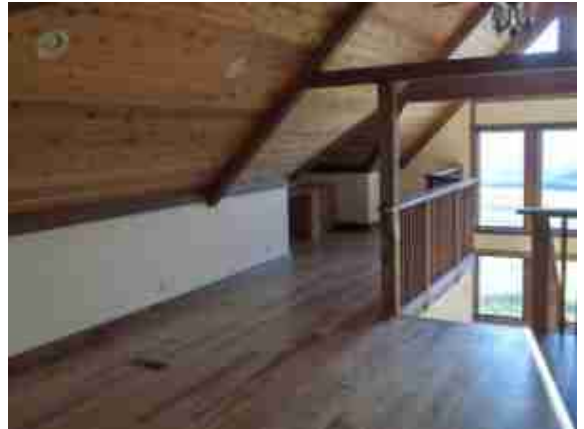
(1756 Sapphire Ranch Trail living room loft 2.)  
i262854BA

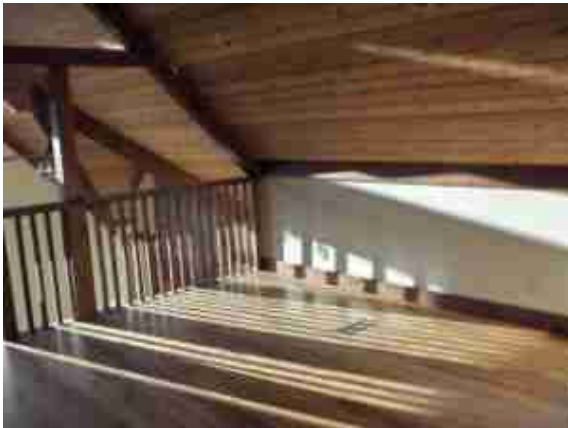
(1756 Sapphire Ranch Trail living room loft 3.)  
i262854BB

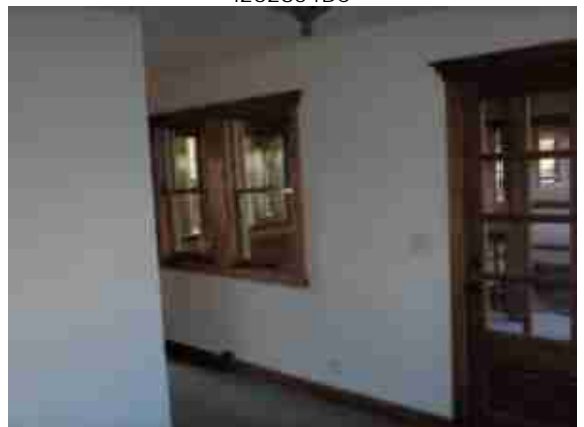
(1756 Sapphire Ranch Trail bedroom #2 2.)  
i262854BE

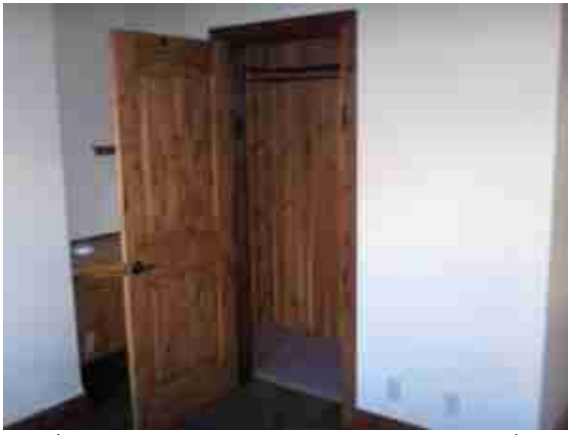
(1756 Sapphire Ranch Trail bedroom #2 3.)  
i262854BF

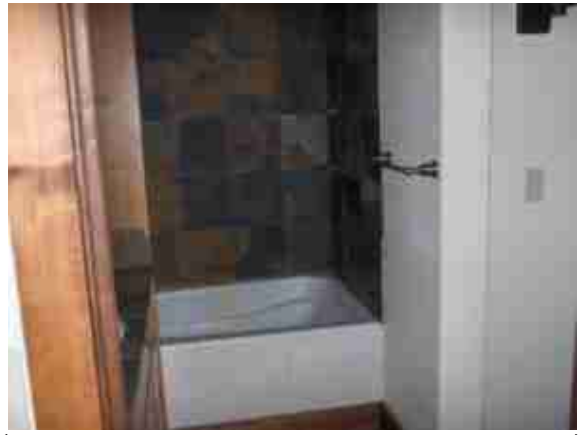
(1756 Sapphire Ranch Trail bedroom #2 bathroom 1.)  
i262854BG

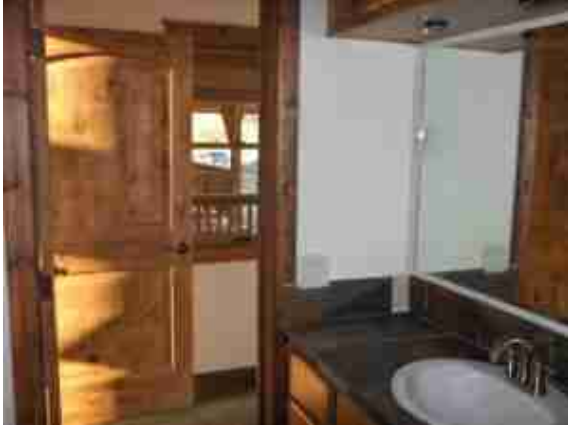
(1756 Sapphire Ranch Trail bedroom #2 bathroom 2.)  
i262854BH

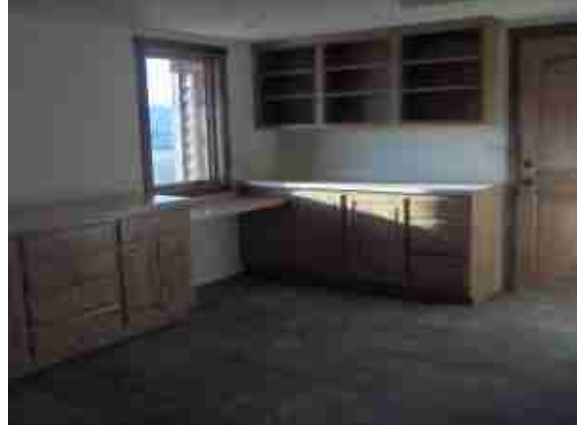
(1756 Sapphire Ranch Trail work room 1.)  
i262854BI

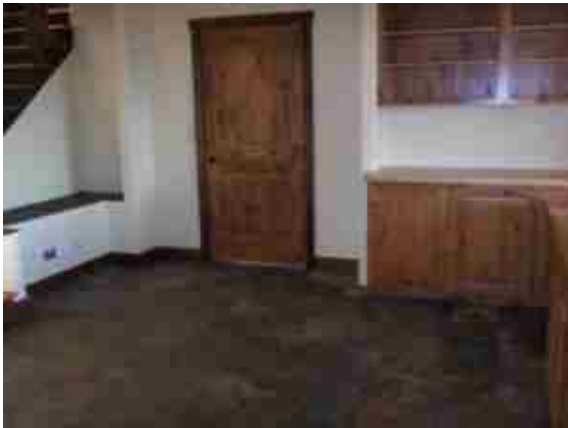
(1756 Sapphire Ranch Trail workroom 2.)  
i262854BJ

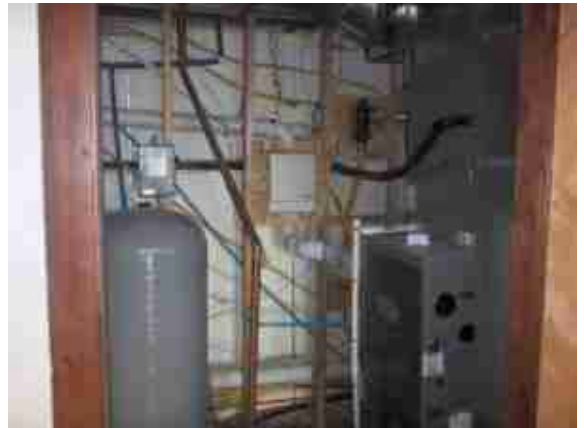
(1756 Sapphire Ranch Trail utility room.)  
i262854BK

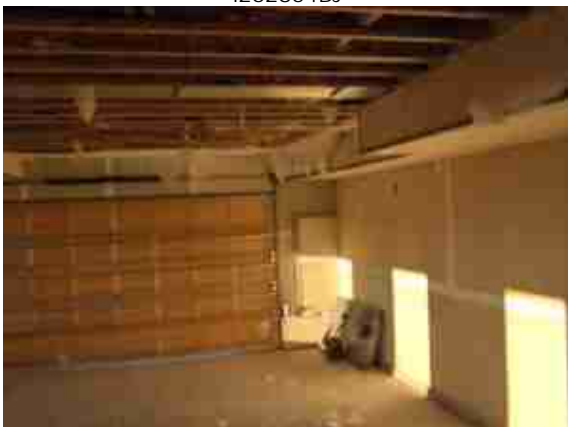
(1756 Sapphire Ranch Trail garage.)  
i262854BL

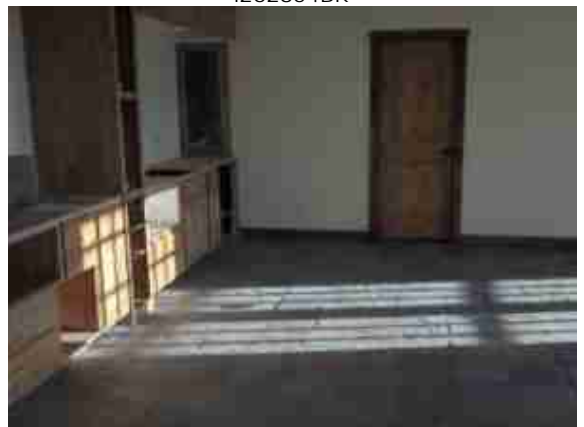
(1756 Sapphire Ranch Trail game room 1)  
i262854BM

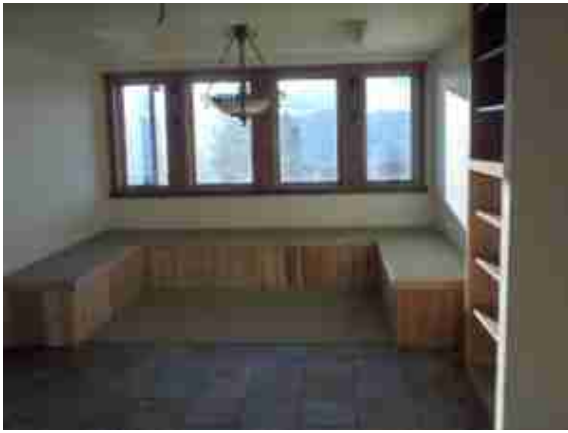
(1756 Sapphire Ranch Trail game room 2.)  
i262854BN

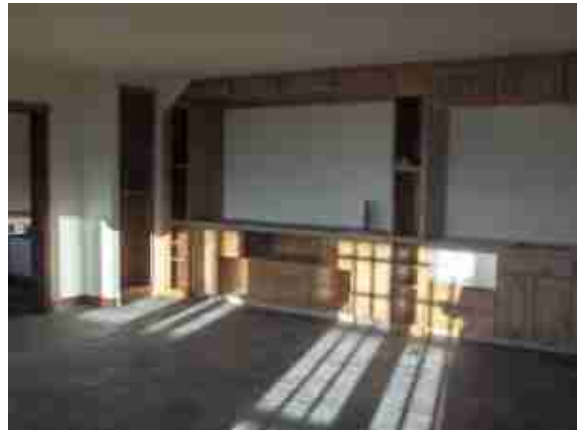
(1756 Sapphire Ranch Trail game room 3.)  
i262854BO

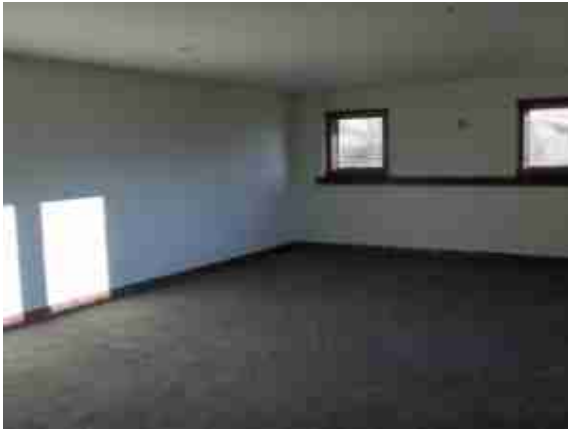
(1756 Sapphire Ranch Trail theater room 1.)  
i262854BP

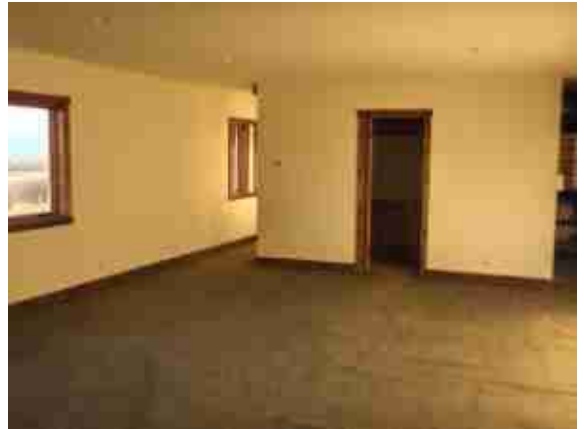
(1756 Sapphire Ranch Trail theater room 2.)  
i262854BQ

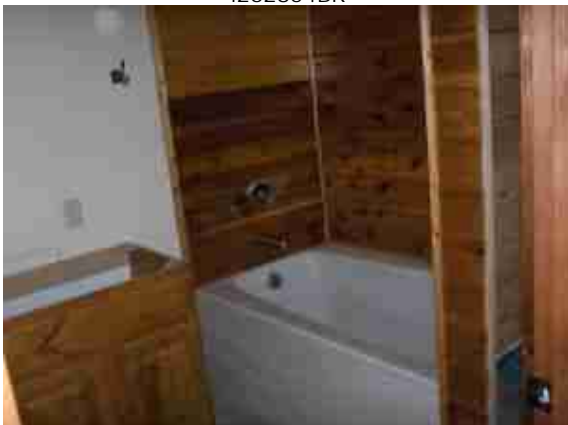
(1756 Sapphire Ranch Trail theater room bathroom.)  
i262854BT

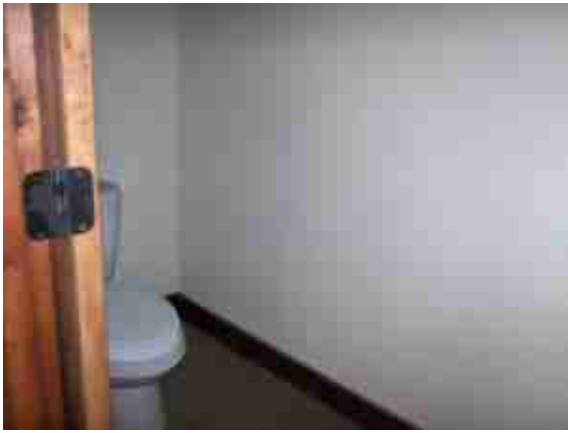
(1756 Sapphire Ranch Trail game room bathroom 1.)  
i262854BV

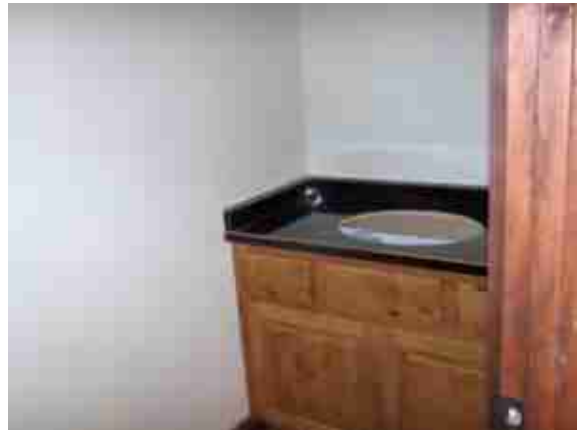
(1756 Sapphire Ranch Trail game room bathroom 2.)  
i262854BW

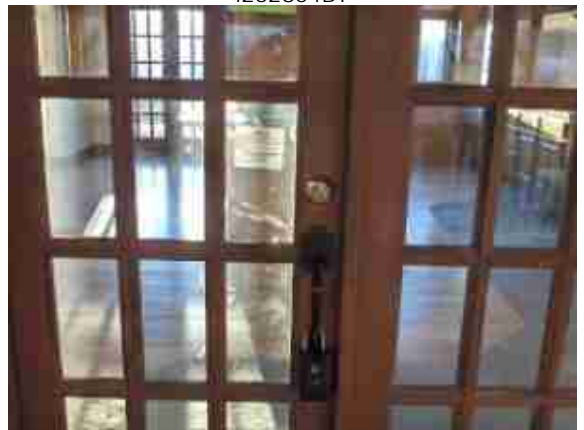
(1756 Sapphire Ranch Trail lockbox in place.)  
i262854CA

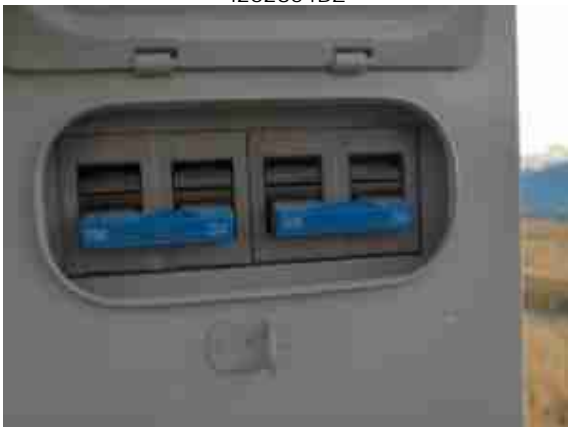
(1756 Sapphire Ranch Trail mains turned off.)  
i262854CB

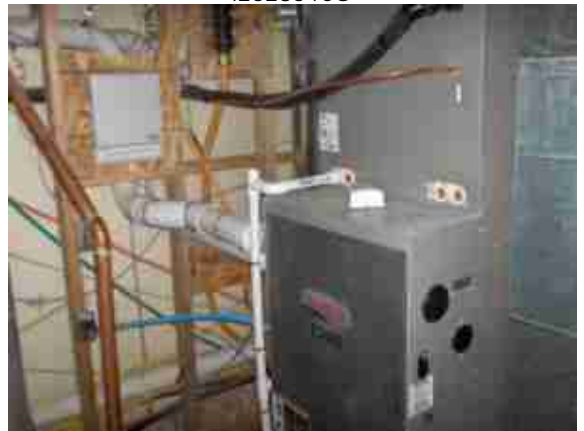
(1756 Sapphire Ranch Trail furnace.)  
i262854CI
